# **Debris/Ice/TPS Assessment And Photographic Analysis For Shuttle Mission STS-42**

March 1992

DEBRIS/ICE/TPS ASSESSMENT  
AND  
PHOTOGRAPHIC ANALYSIS  
OF  
SHUTTLE MISSION STS-42

January 22, 1992

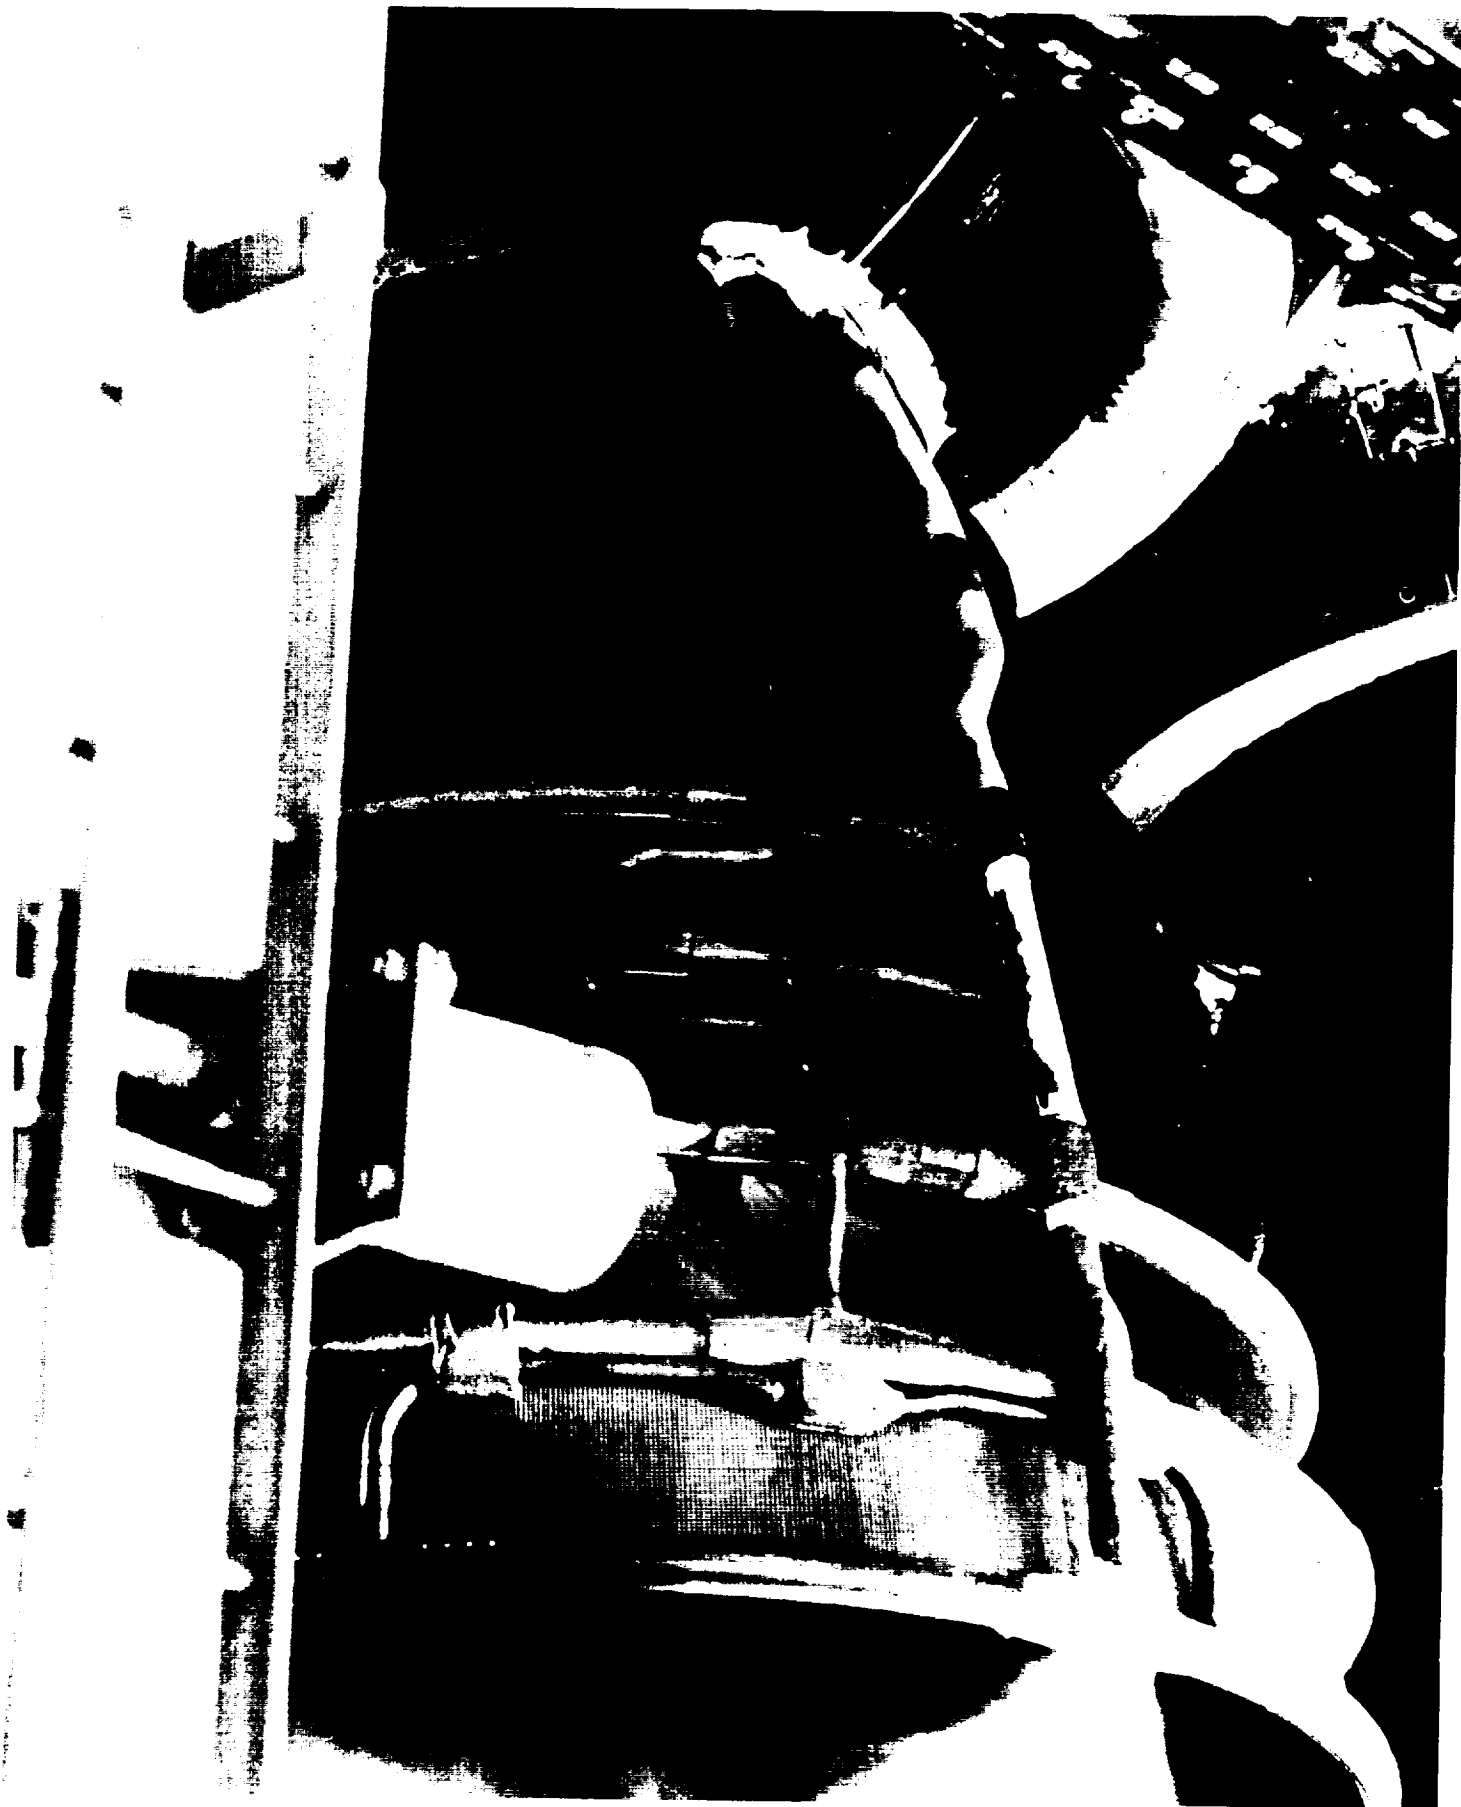
Frost coated the SSME #2 drain line and engine-mounted heat shield-to-nozzle interface along the full circumference. Some condensate was also present on the engine mounted heat shield.

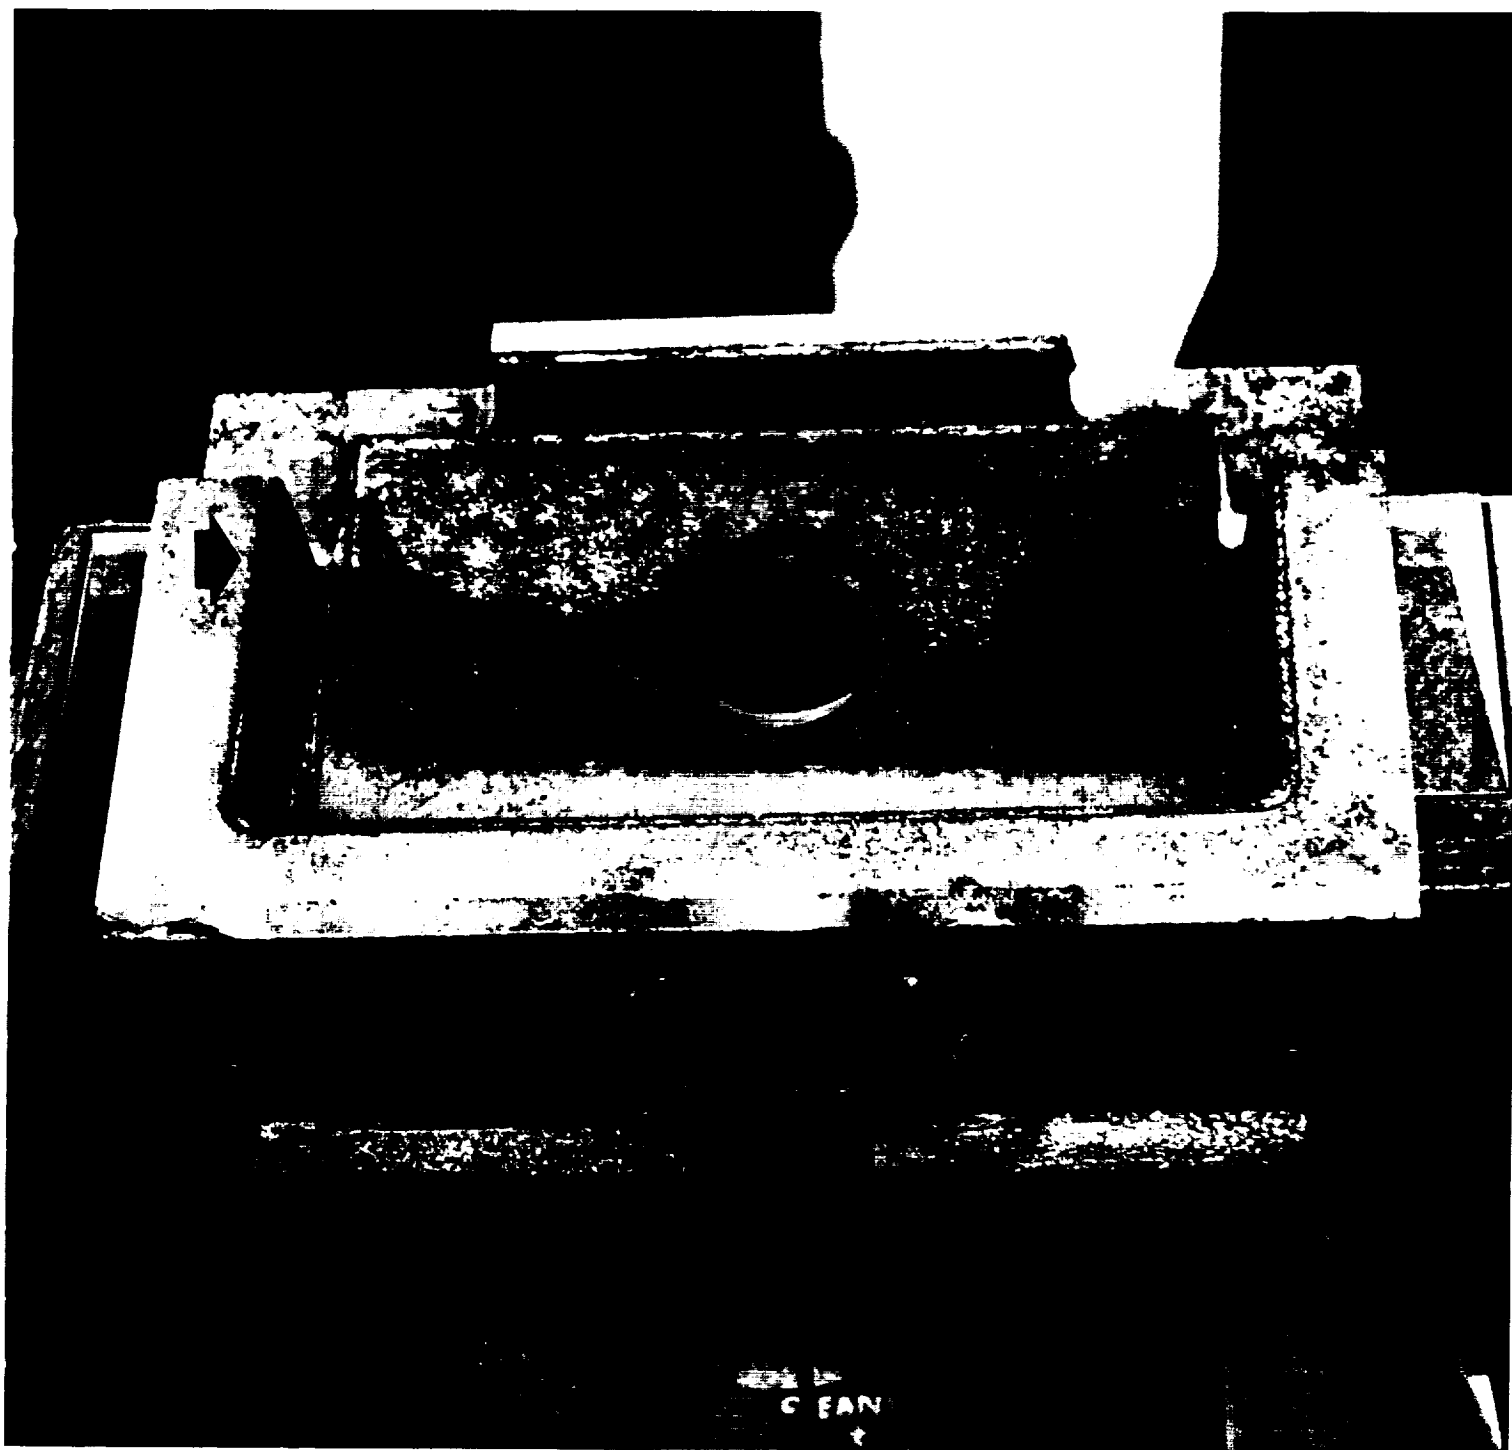
Plume erosion of the south SRB holddown posts was typical. EPON shim material was intact, but slightly debonded from the holddown post shoe sidewalls on HDP #1, #2, and #6. There was no visual indication of a stud hang-up on any of the south holddown posts.

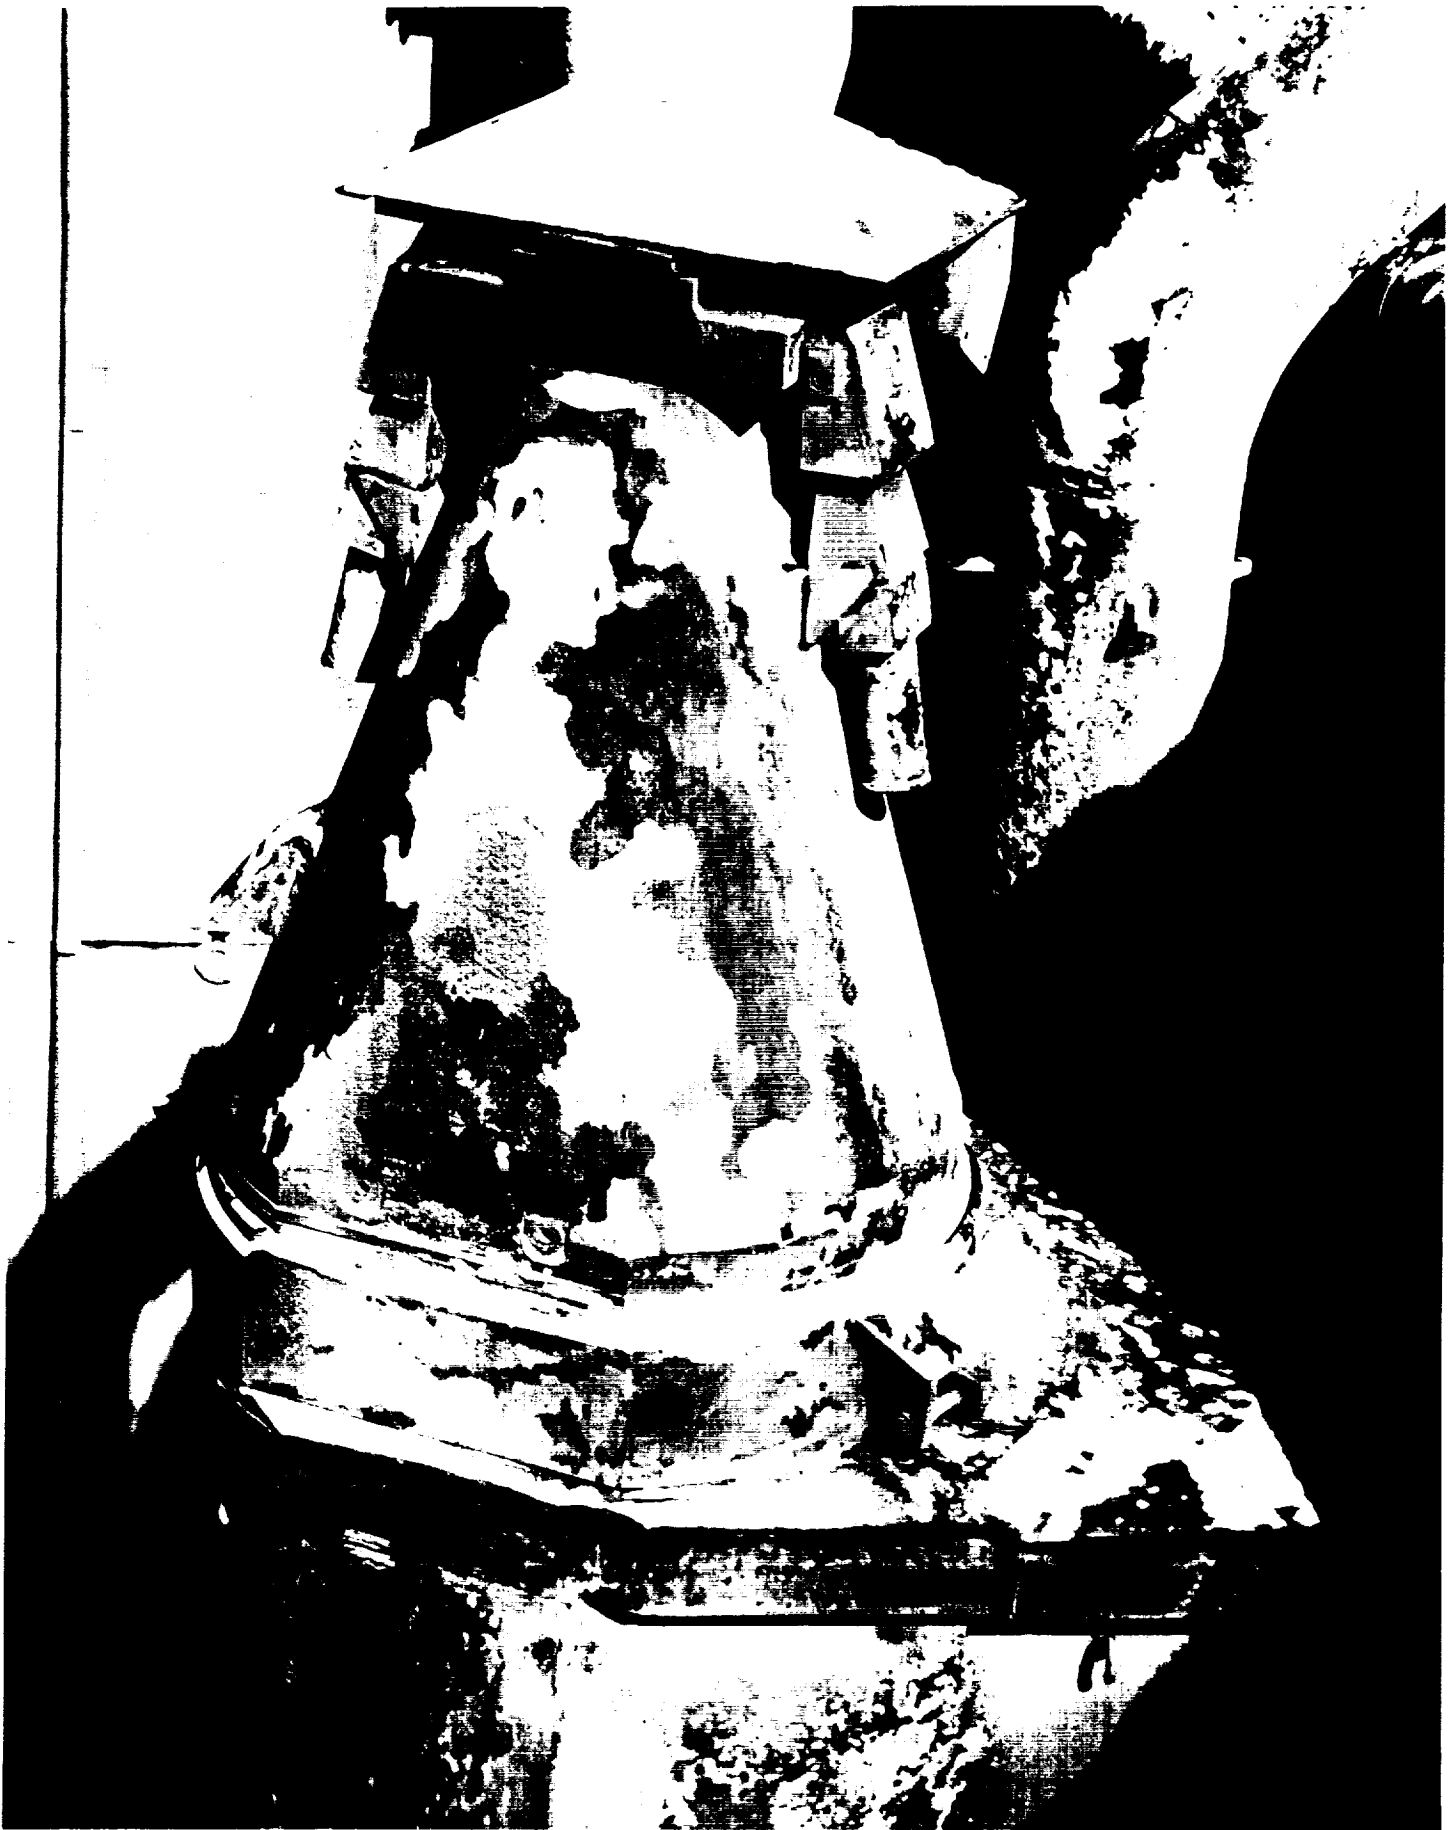
North HDP blast covers were in the closed position and exhibited typical SRB plume erosion effects

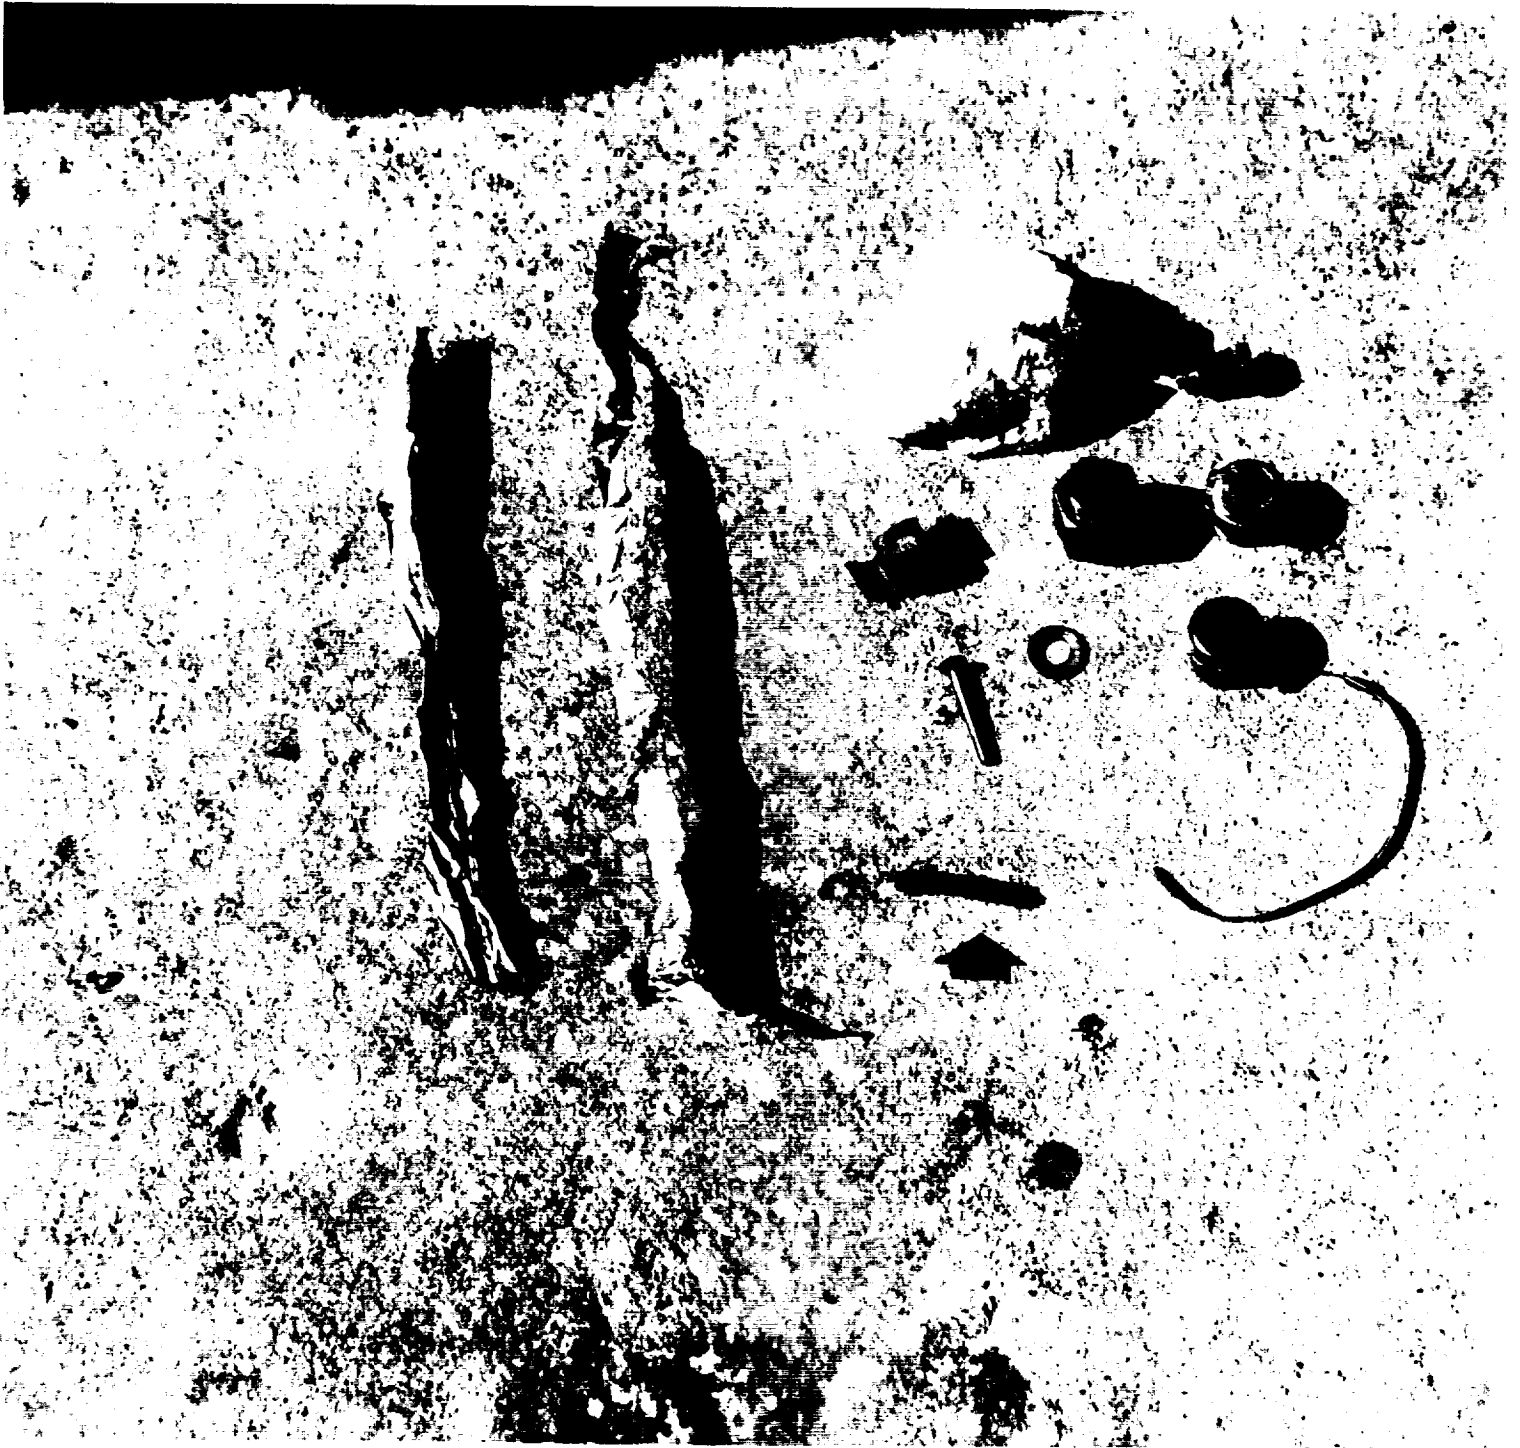
Typical post launch debris included SRB holddown post frangible nut web (2.0x0.25 inches), SRB throat plug material, facility bolts and hardware, pneumatic line caps/covers, and strips of insulation.

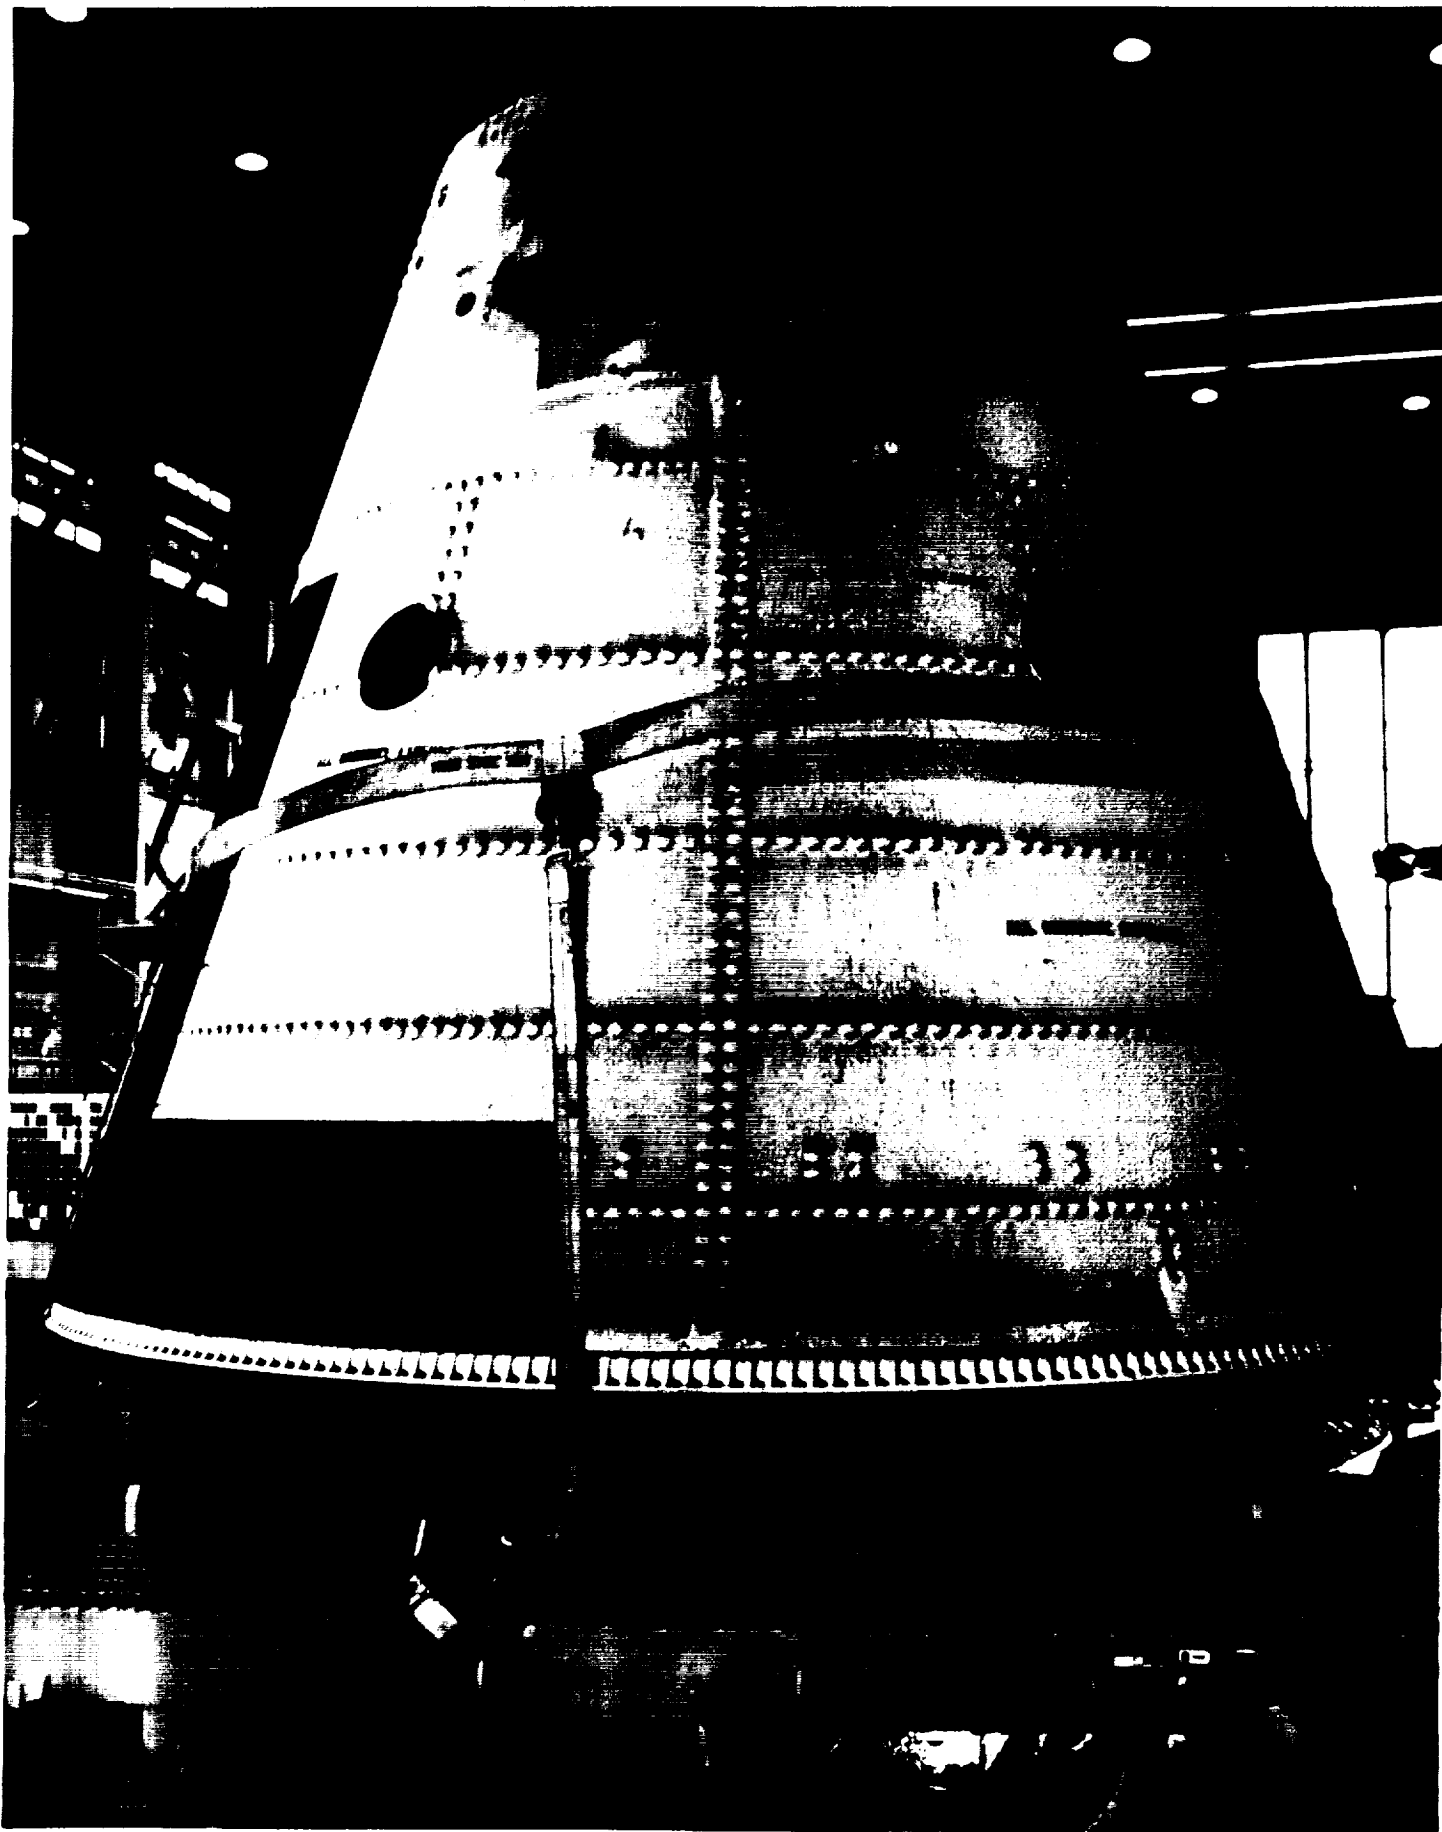
The RH frustum was missing no TPS but had 14 MSA-2 debonds over fasteners. There was minor localized blistering of the Hypalon paint.

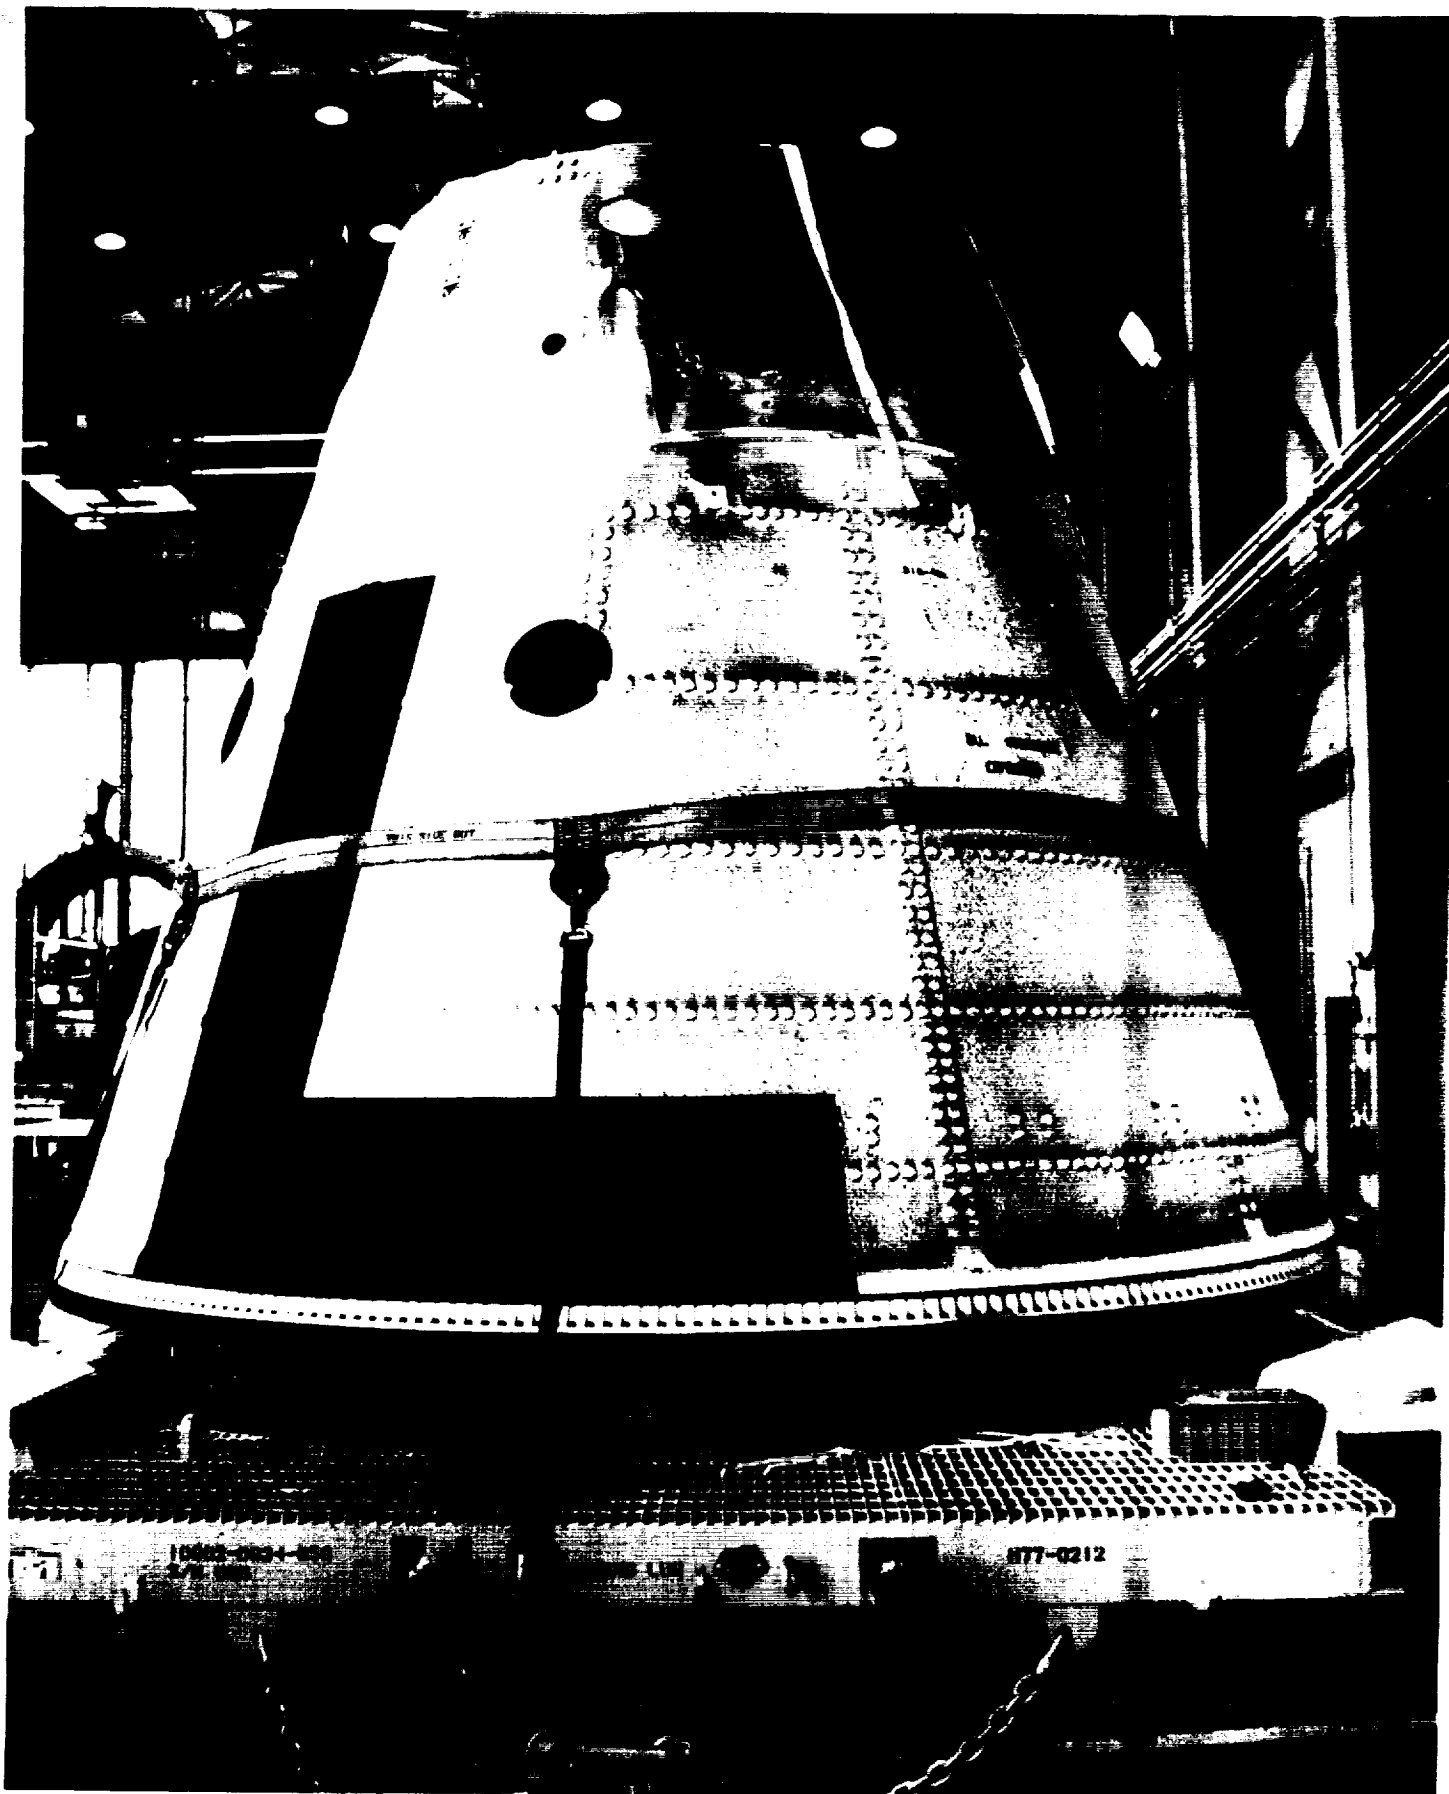
The LH frustum was missing no TPS but had 10 MSA-2 debonds over fasteners. The BSM covers were locked in the fully opened position though the lower left cover attach ring was deformed and the cover bent back to the 150 degree position.

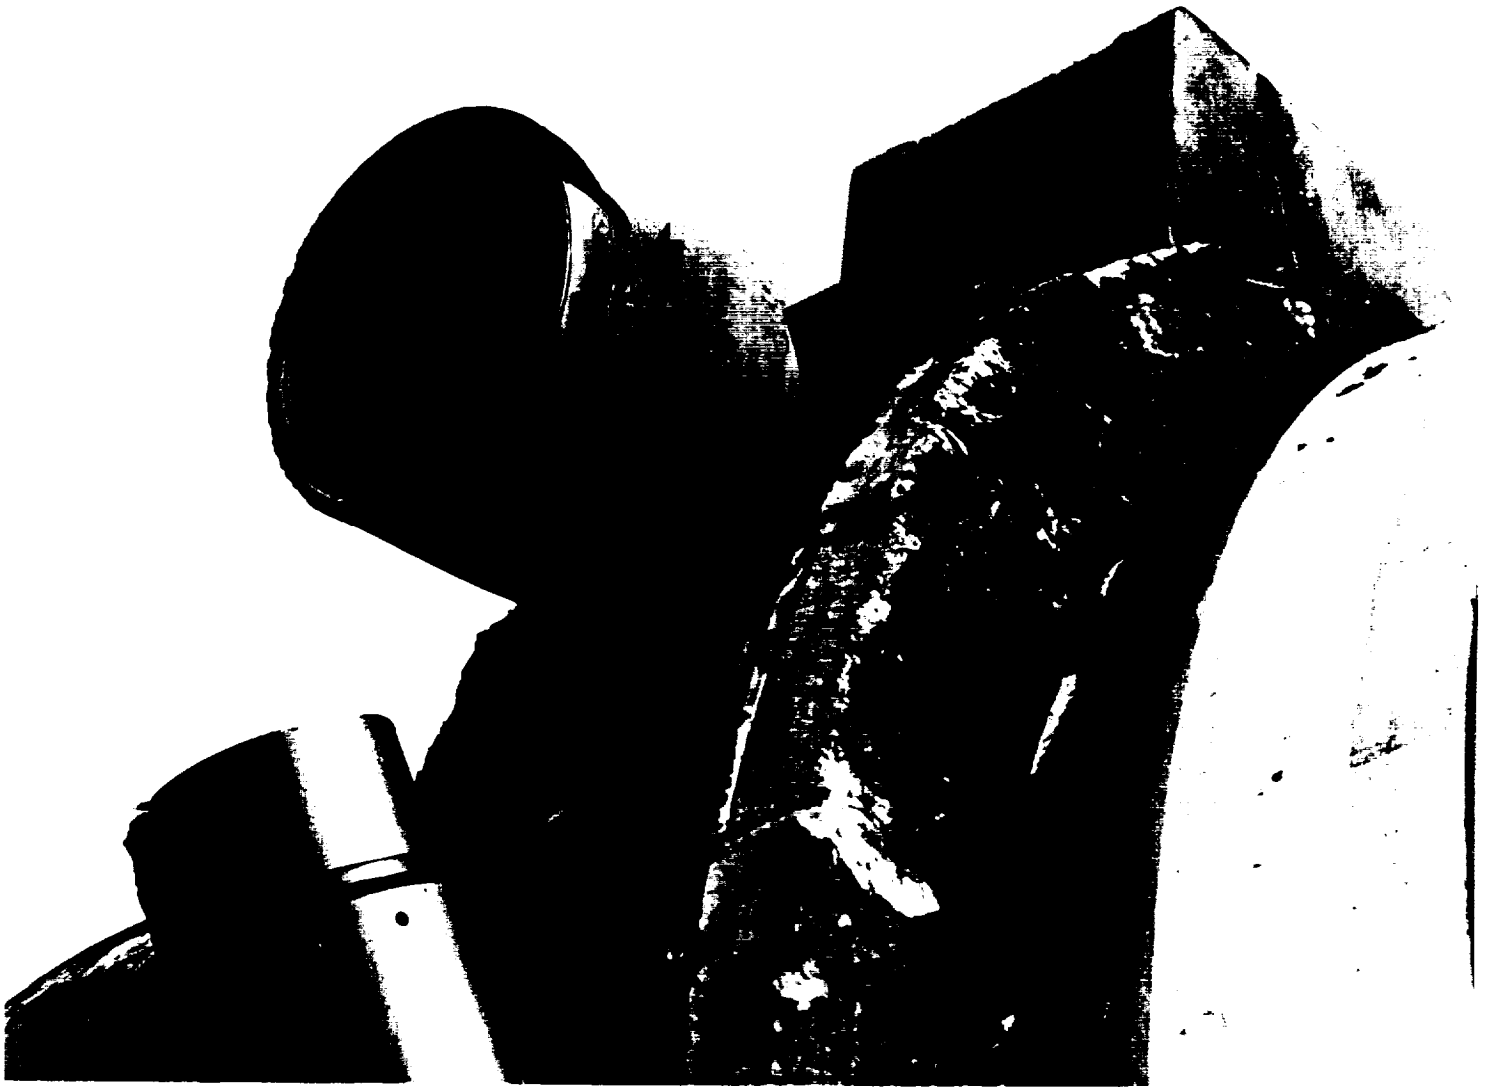
A 3"x1" area of TPS on the forward side of the ET/SRB upper strut fairing at the separation plane was missing and the substrate was charred. The loss of TPS in this area may have occurred during strut separation.

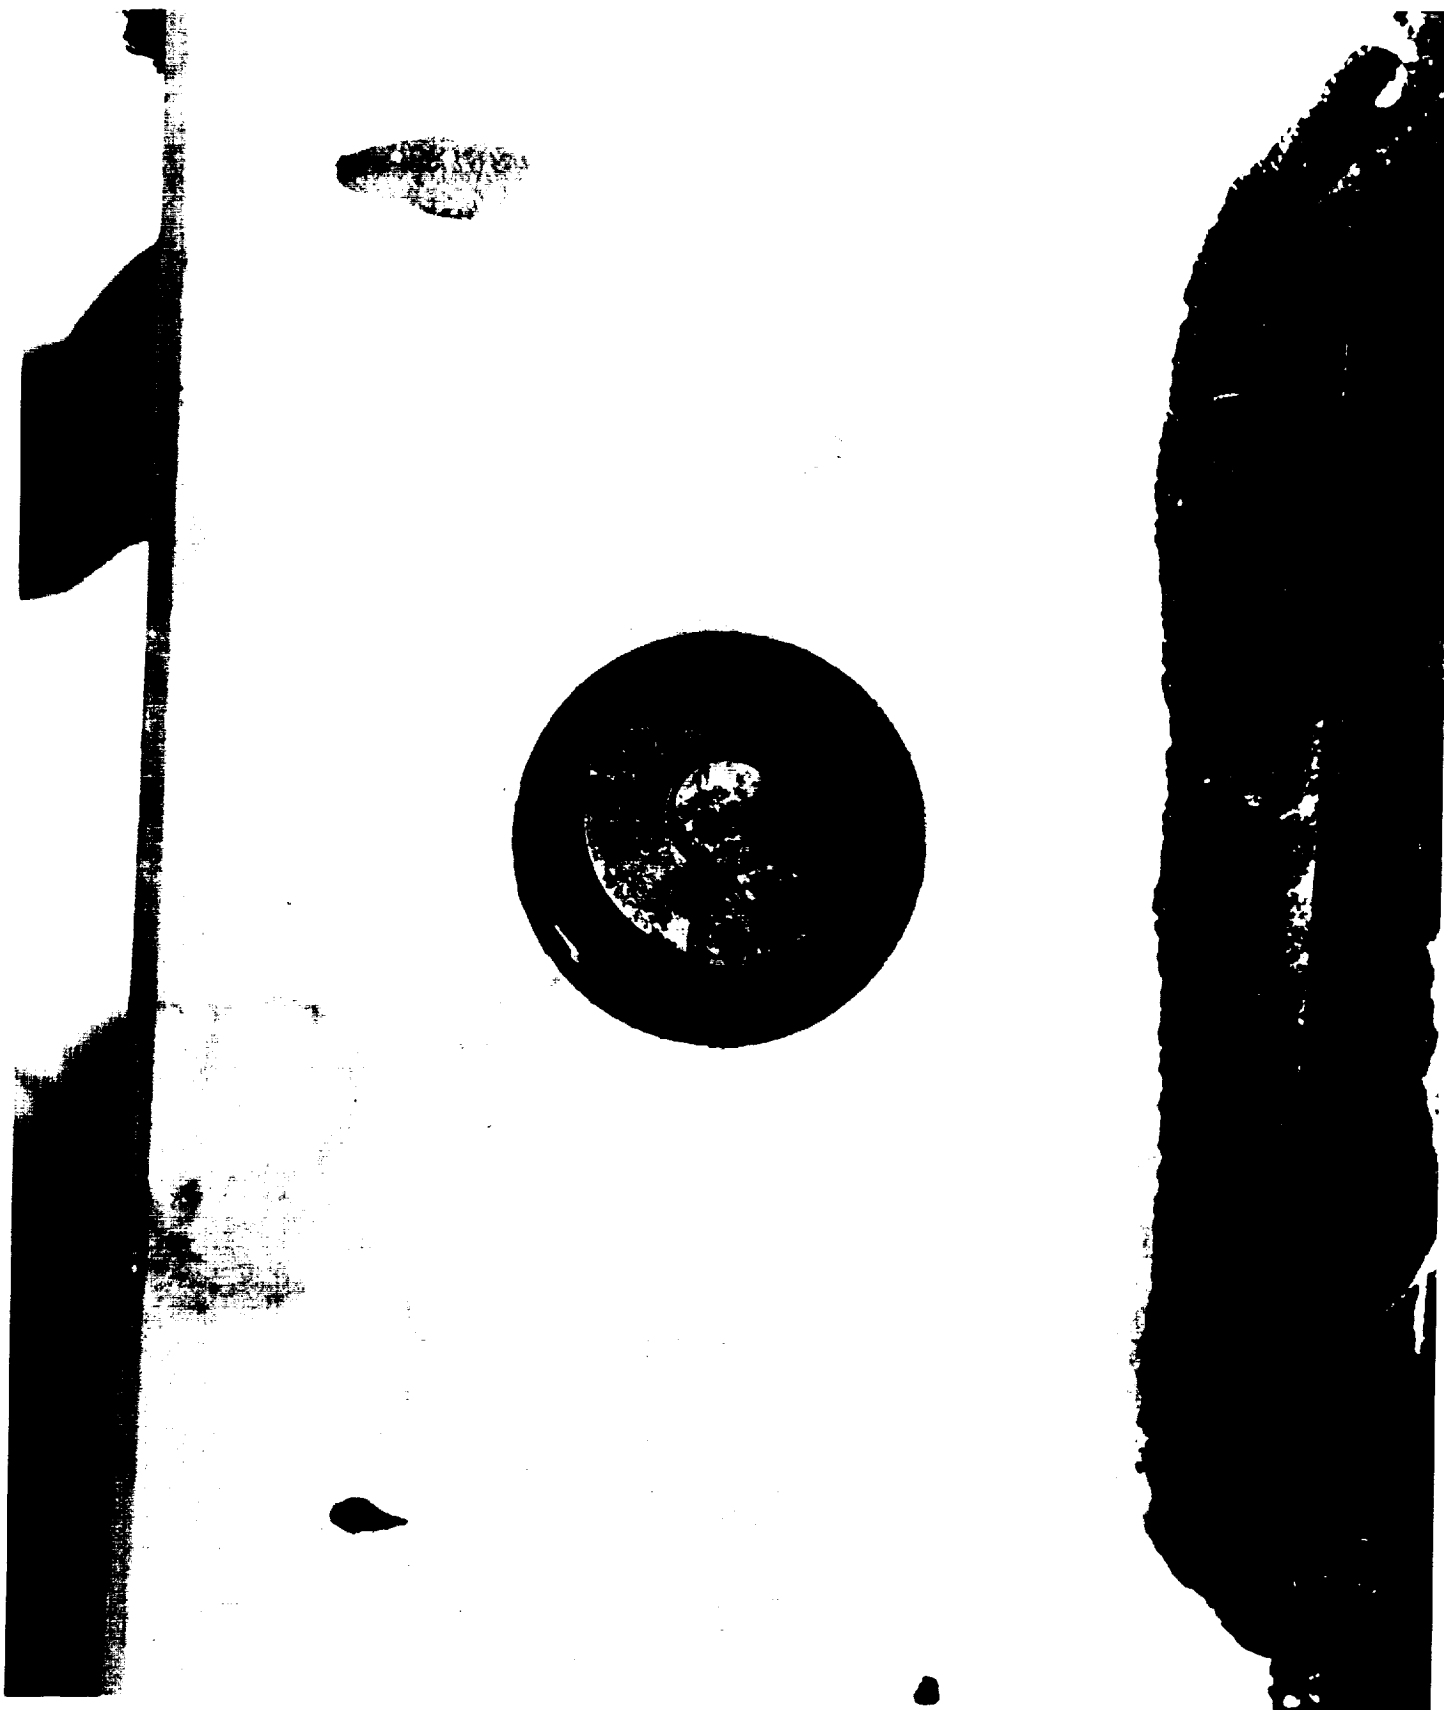
All four HDP Debris Containment System plungers were seated. There was no sign of breaching in any of the stud holes. Approximately 10 percent of the HDP #7 EPON shim was missing prior to splashdown and the substrate was charred.

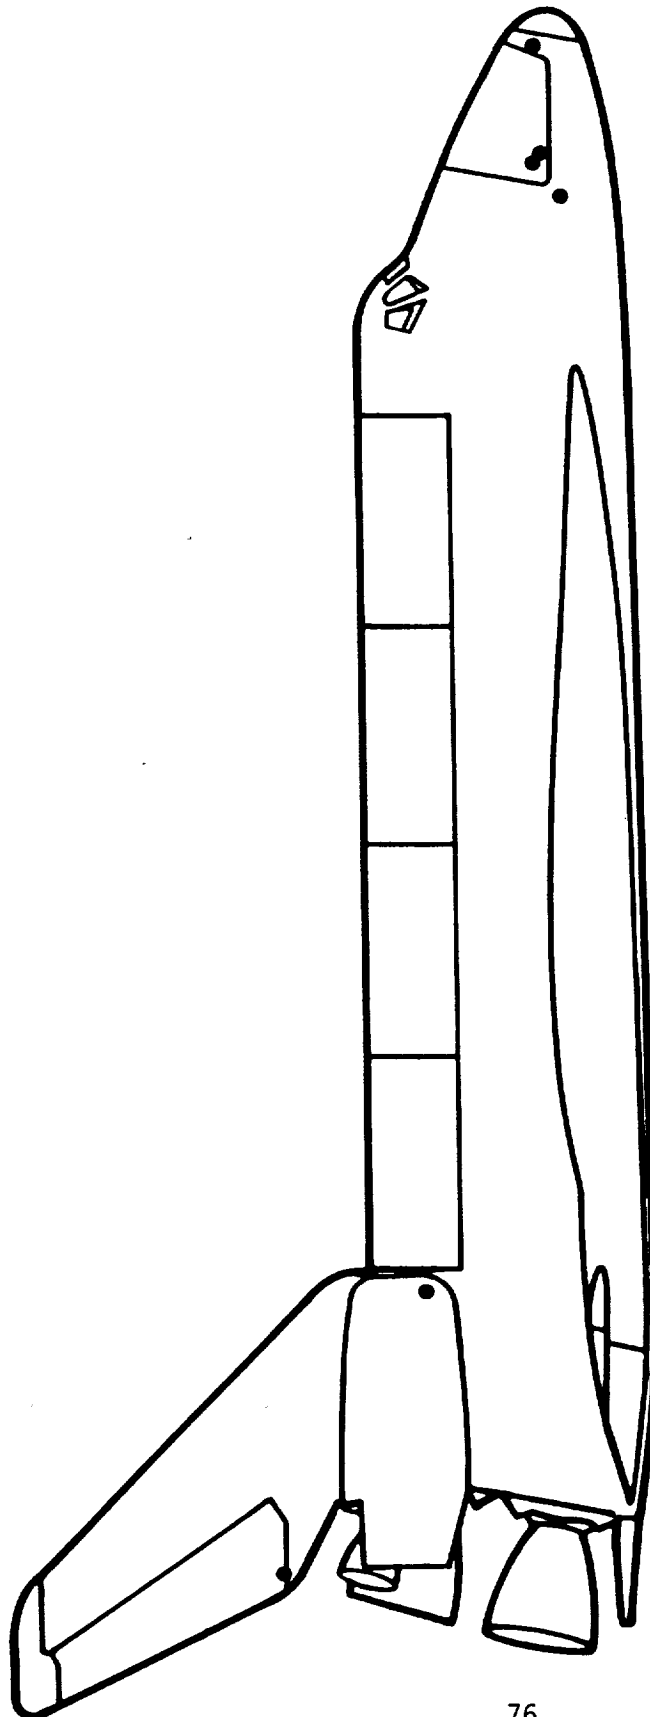
Figure 11. STS-42  
**DEBRIS DAMAGE LOCATIONS**

TOTAL HITS = 6  
HITS > 1 INCH = 0

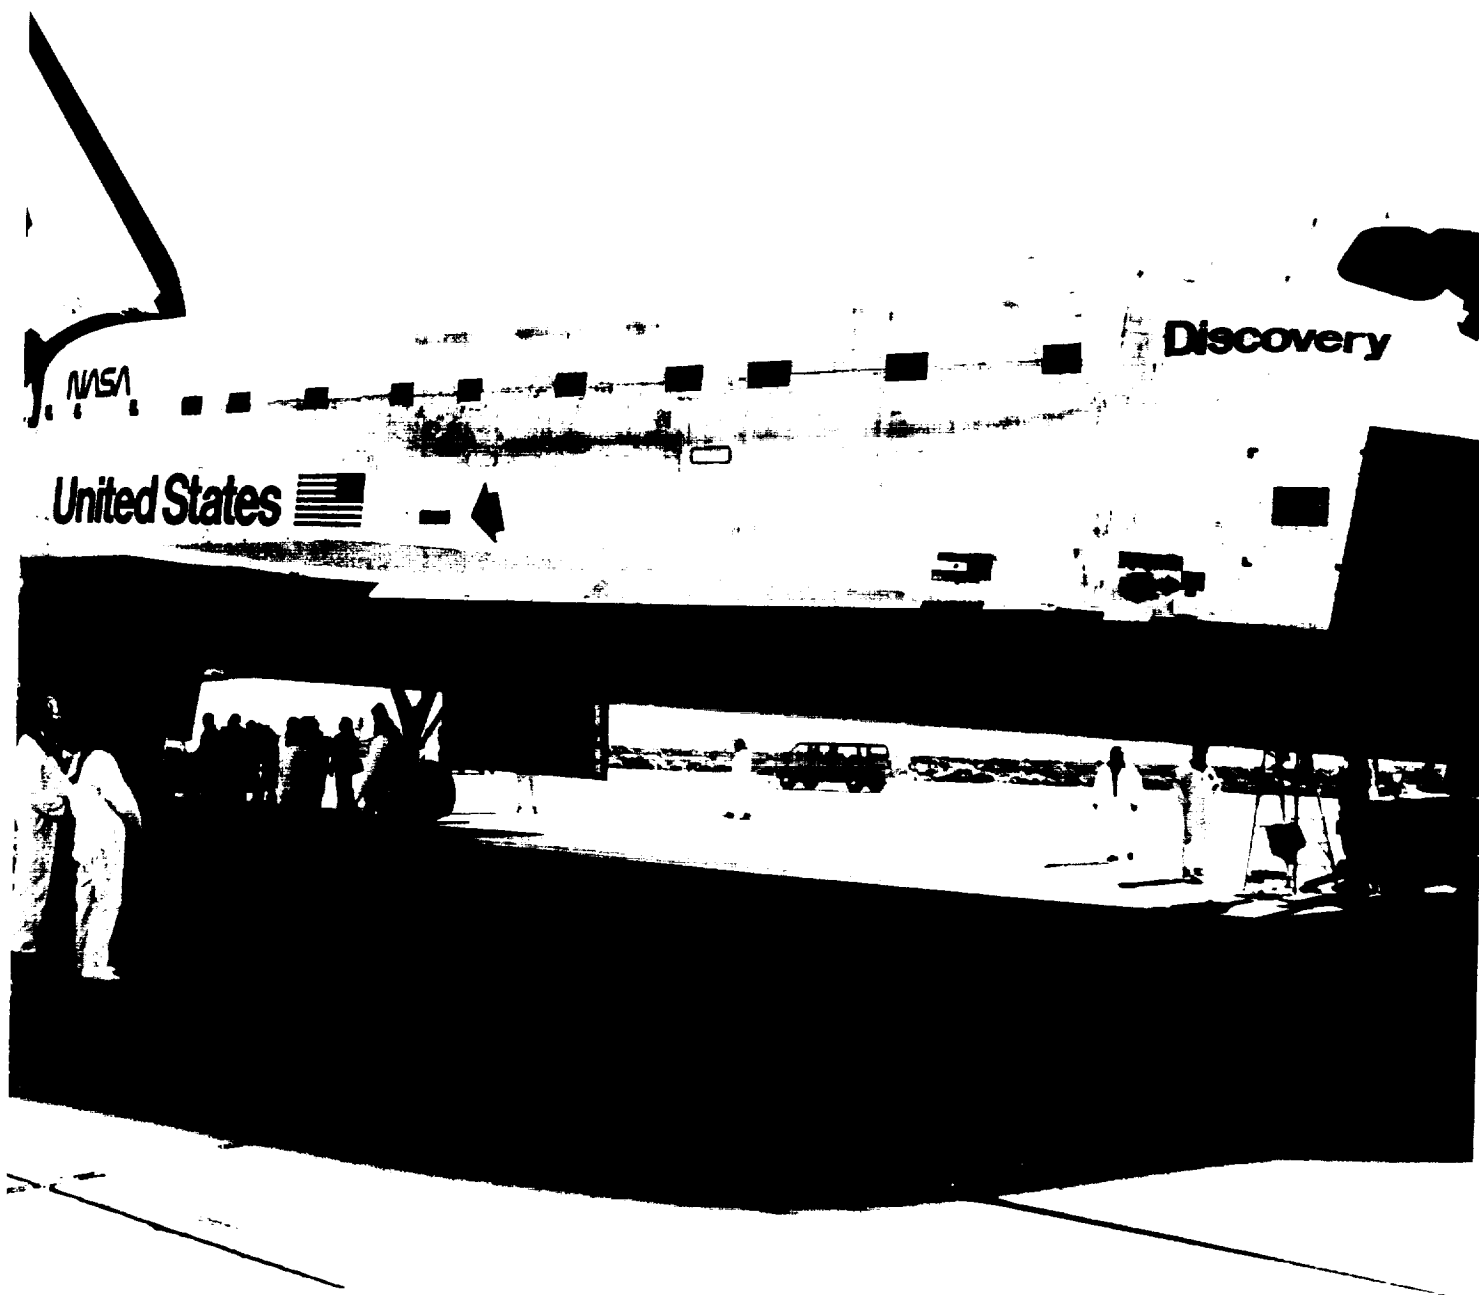
Overall view of Orbiter right side. Streaks on payload bay door and fuselage may be related to on-orbit leak of aft RCS thruster. Note yellow discoloration of vent door #7.
